Bulletin No.:	9573L30-01
Corp. Rel. No.:	57-71-09
Date:	April, 1995

Product Service Bulletin

SUBJECT: TORQUE CONVERTER CLUTCH (TCC) CHUGGLE/HUNTING CONDITION

MODELS: 1989-1995 GEO TRACKER, CAMI VITARA, SUZUKI SIDEKICK
WITH HYDRA-MATIC 3L30 AUTOMATIC TRANSMISSION

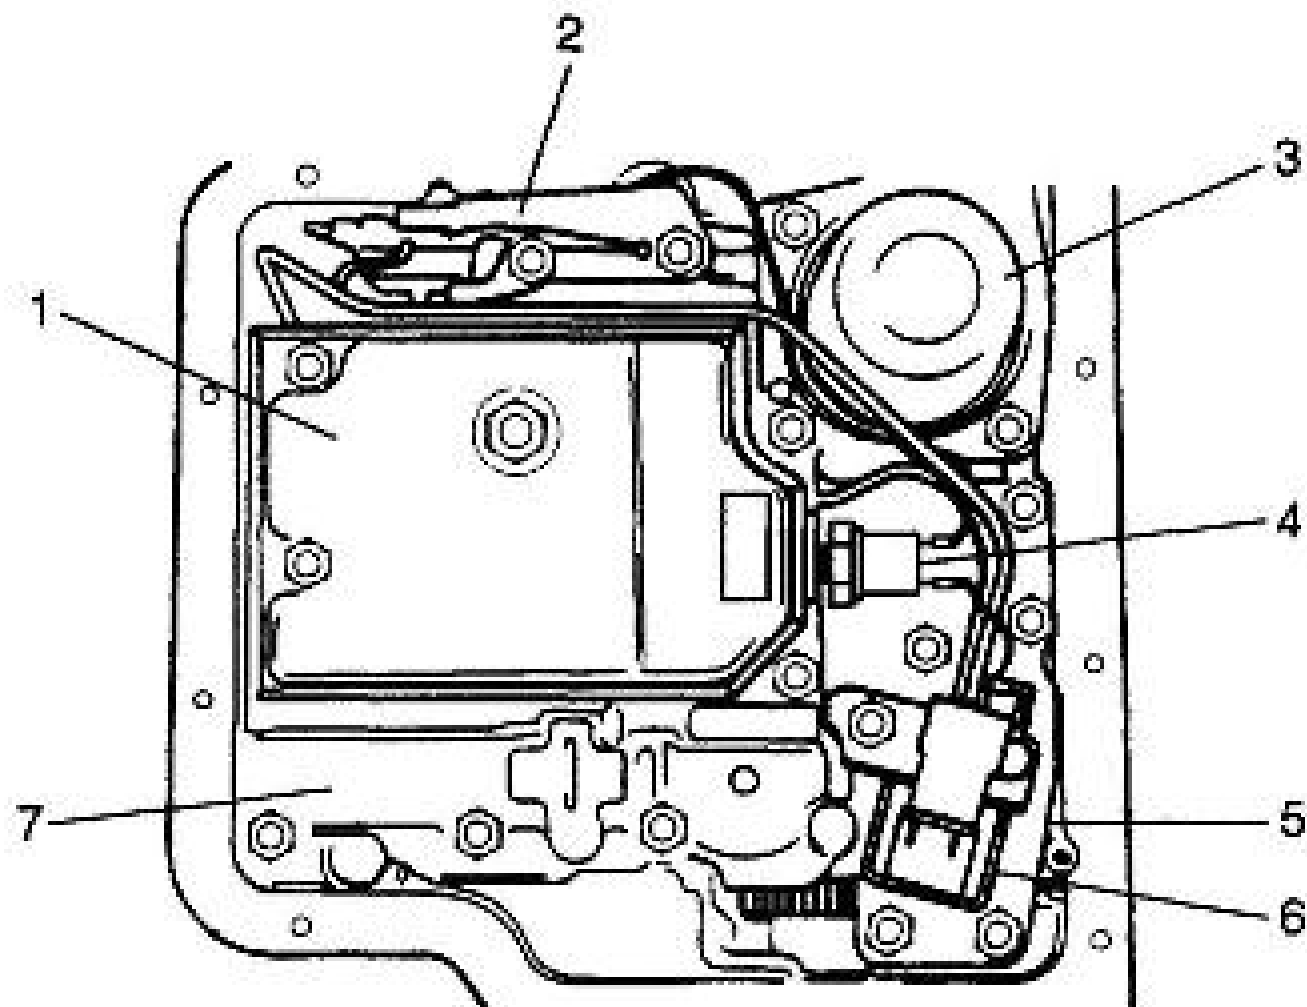
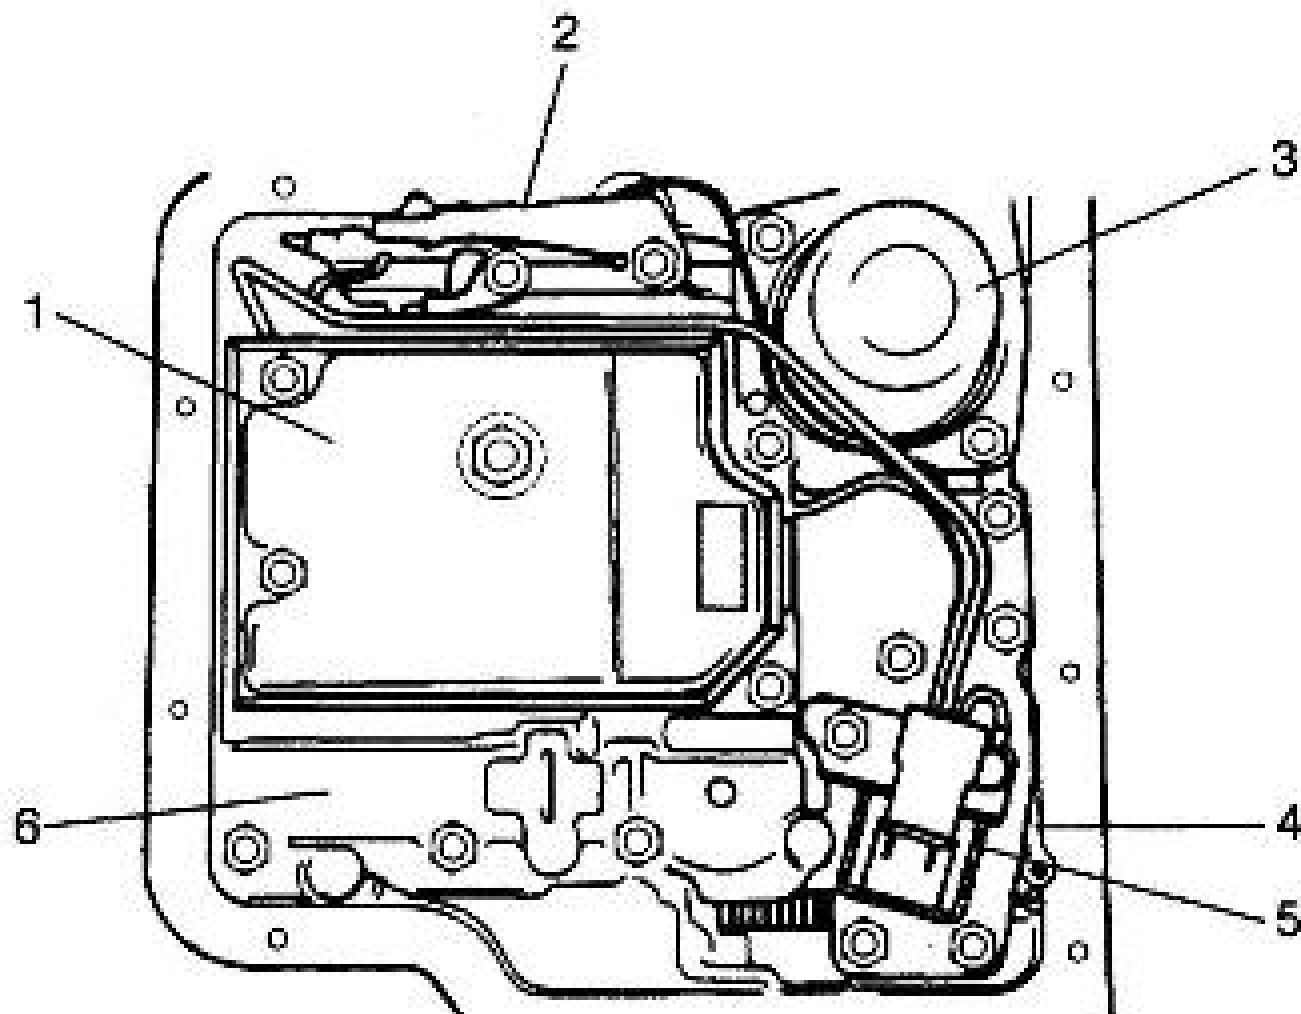
CONDITION: Change in Automatic Transmission; elimination of A/T oil pressure switch.

This bulletin is to inform you of the elimination of the Torque Converter Clutch (TCC) Oil Pressure Switch which has been carried out since May 1995 production for Canadian models and August 1995 production for Japan models. Due to this modification, the diagnostic procedures for the TCC system in the service manual have been changed. Please refer to Technical Service Bulletin #TS 3-25 to diagnose this system.

For diagnostic procedure, please refer to Technical Service Bulletin #TS 3-25. Also note that the continuity check between ① pin of TCC relay coupler and ground is not needed due to the elimination of the A/T oil pressure switch.

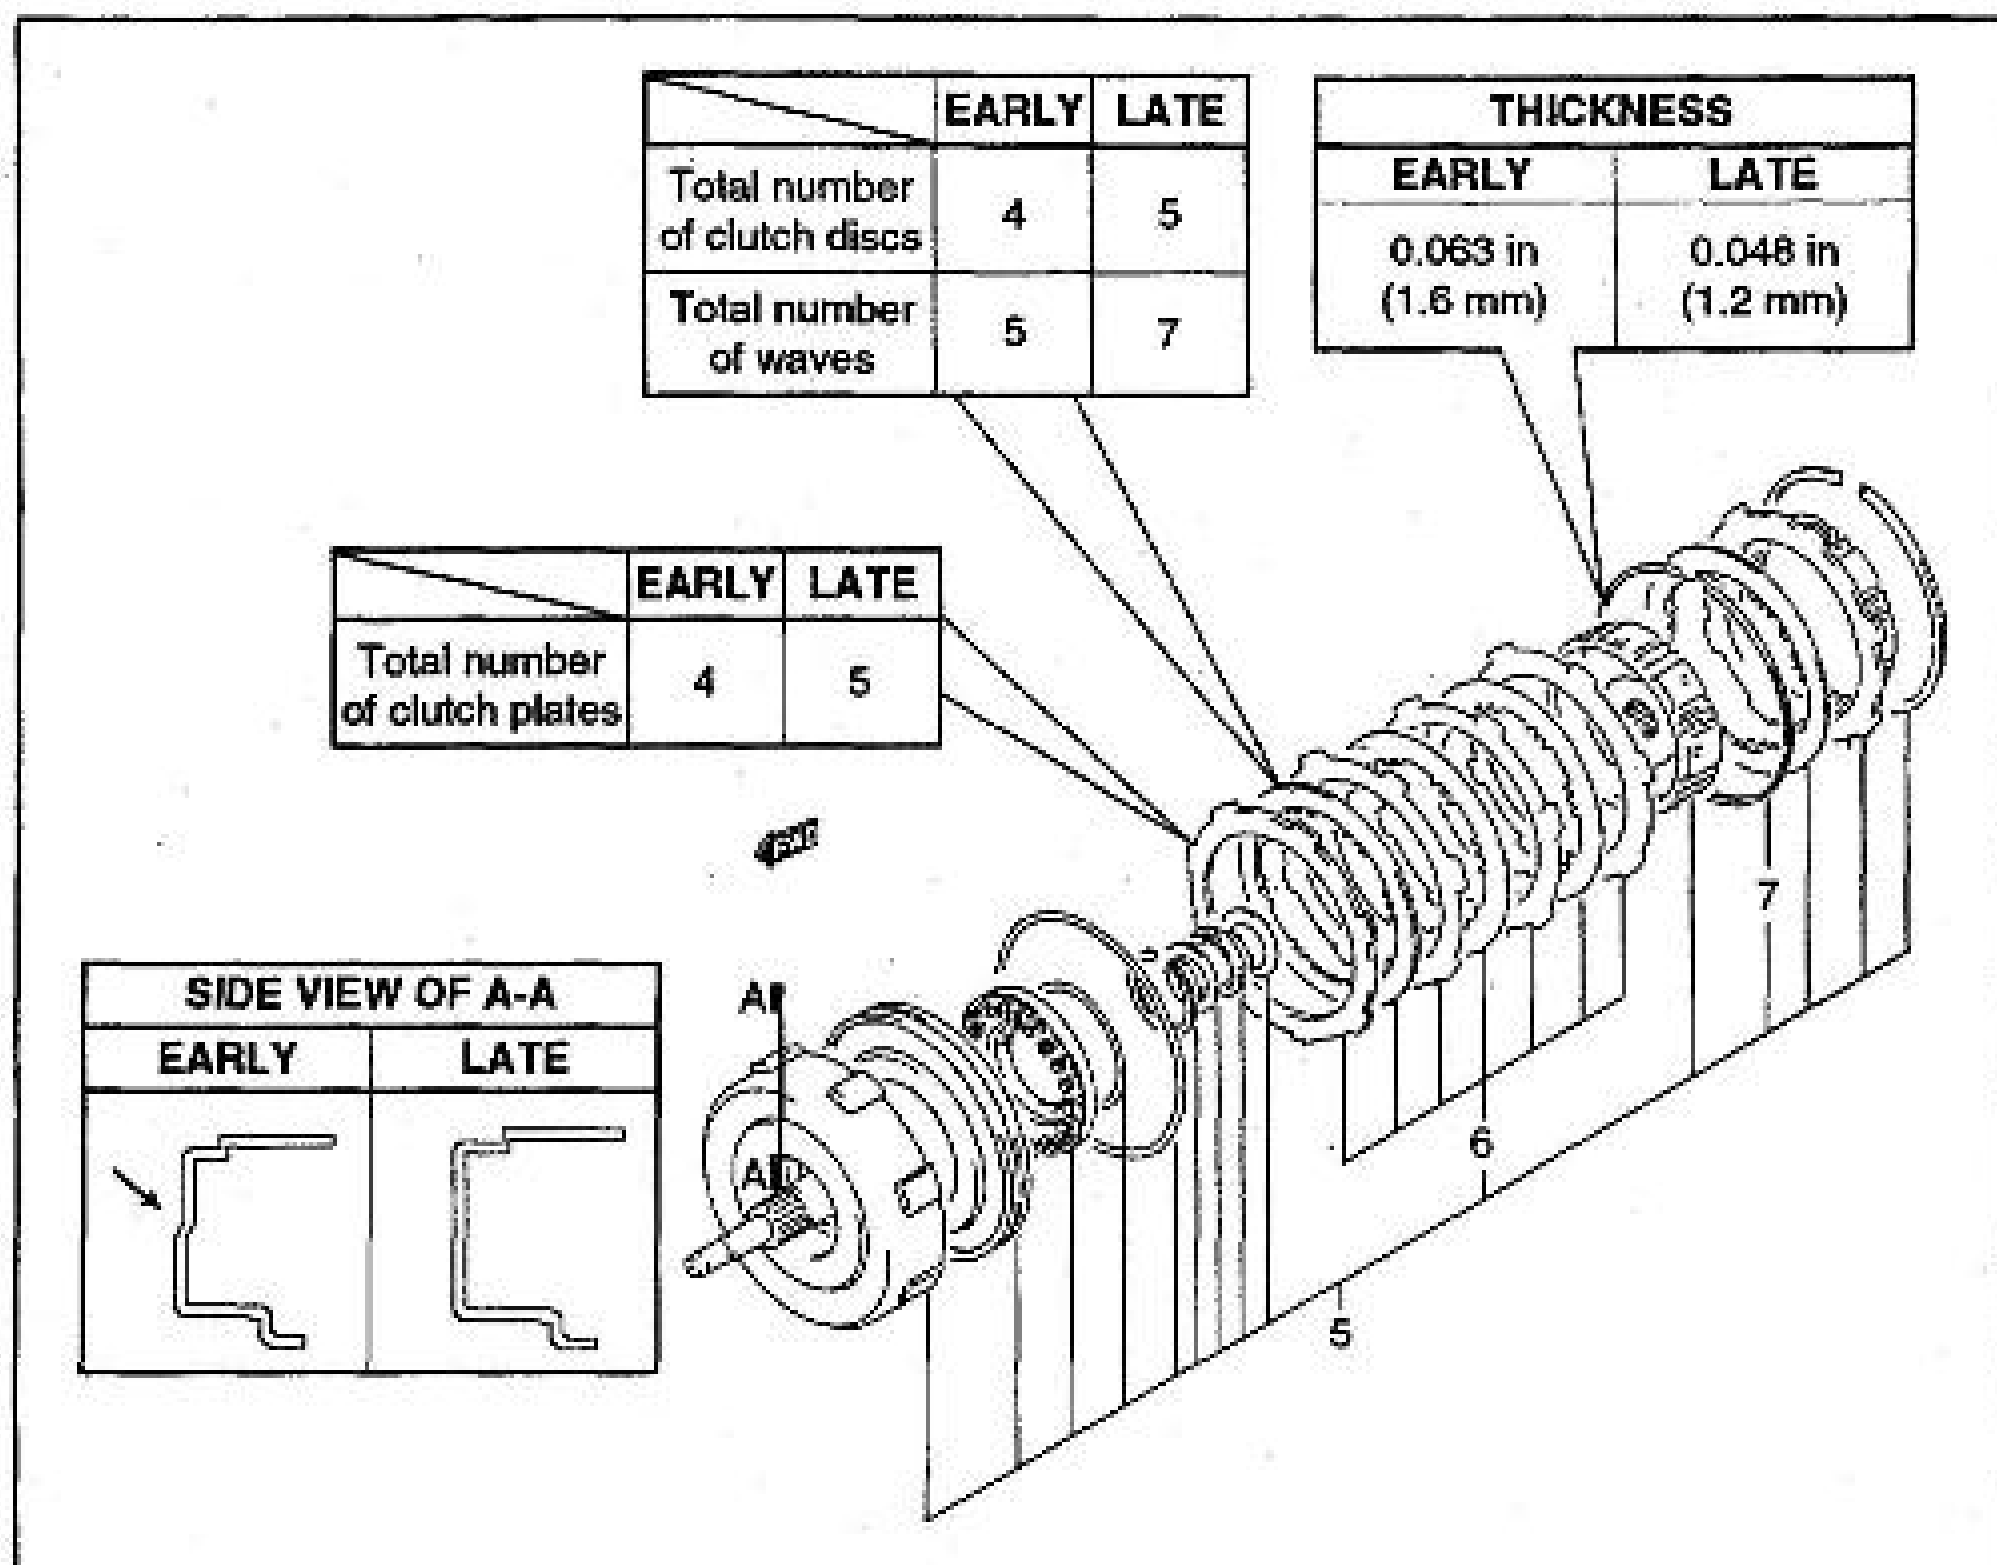
CONDITION: Excessive gear shift shock.

This bulletin is to inform you of the modification of the inner parts for the 4-Speed Automatic Transmission which has been carried out since January 1997 production. The modifications listed in this bulletin were introduced to reduce gear shift shock when shifting from Neutral to Drive, Neutral to Reverse, and First to Second gears. When rebuilding the transmission, please use the parts as listed in this bulletin.

CORRECTION: Install updated parts as listed in this bulletin.
