Bulletin No.:	9573L30-01
Corp. Ref. No.:	57-71-09
Date:	April, 1995

Product Service Bulletin

SUBJECT: TORQUE CONVERTER CLUTCH (TCC) CHUGGLE/HUNTING CONDITION

MODELS: 1989-1995 GEO TRACKER, CAMI VITARA, SUZUKI SIDEKICK WITH HYDRA-MATIC 3L30 AUTOMATIC TRANSMISSION

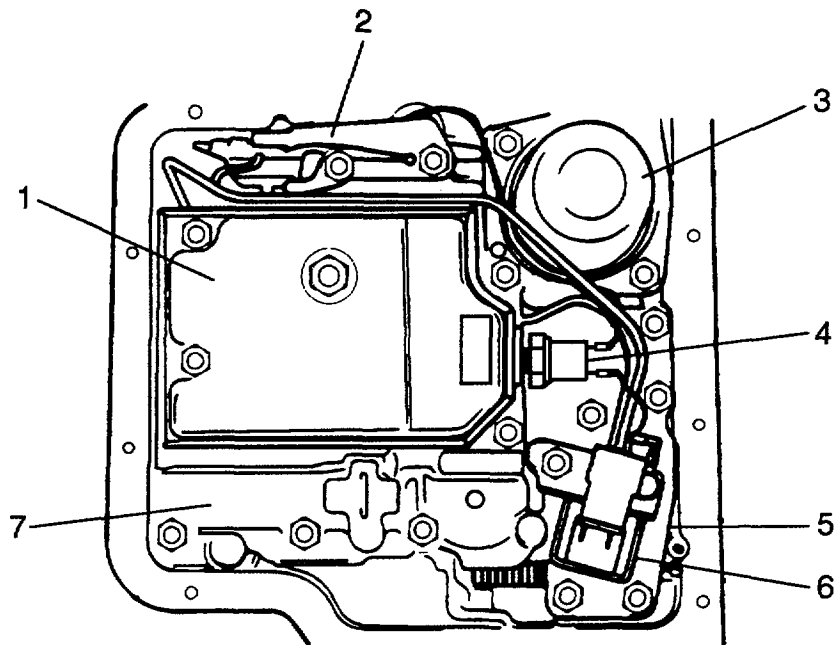
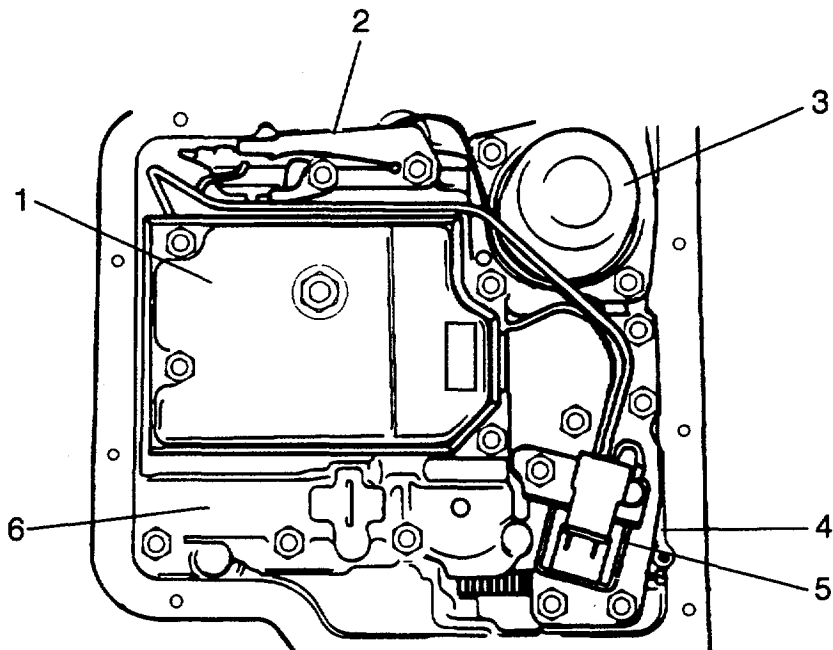
CONDITION: Change in Automatic Transmission; elimination of A/T oil pressure switch.

This bulletin is to inform you of the elimination of the Torque Converter Clutch (TCC) Oil Pressure Switch which has been carried out since May 1995 production for Canadian models and August 1995 production for Japan models. Due to this modification, the diagnostic procedures for the TCC system in the service manual have been changed. Please refer to Technical Service Bulletin #TS 3-25 to diagnose this system.

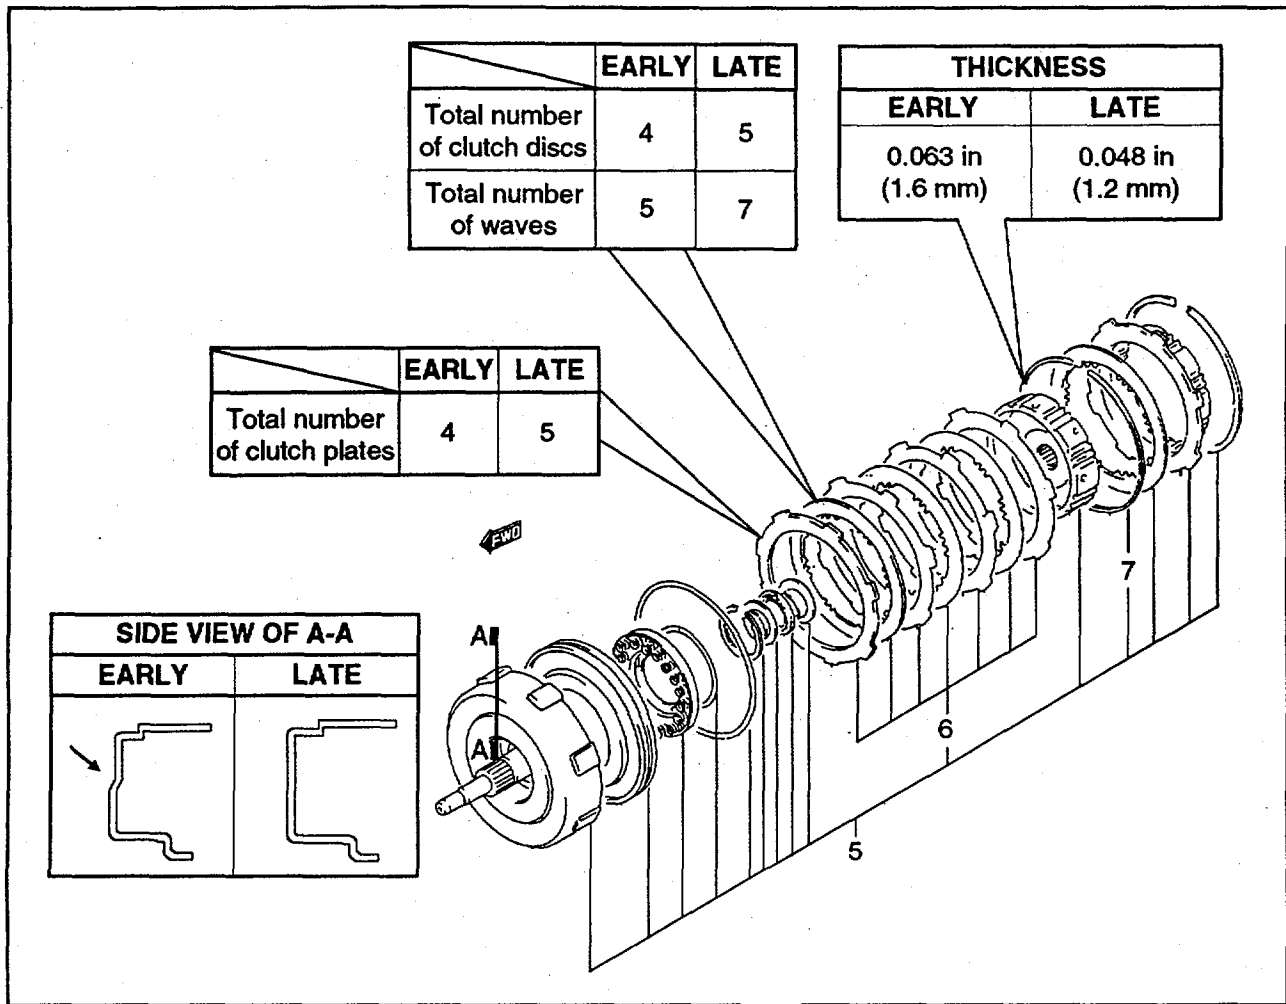
CONDITION: Excessive gear shift shock.

This bulletin is to inform you of the modification of the inner parts for the 4-Speed Automatic Transmission which has been carried out since January 1997 production. The modifications listed in this bulletin were introduced to reduce gear shift shock when shifting from Neutral to Drive, Neutral to Reverse, and First to Second gears. When rebuilding the transmission, please use the parts as listed in this bulletin.

CORRECTION: Install updated parts as listed in this bulletin.
