Bulletin No.:	9573L30-01
Corp. Rel. No.:	57-71-09
Date:	April, 1995

Product Service Bulletin

SUBJECT: TORQUE CONVERTER CLUTCH (TCC) CHUGGLE/HUNTING CONDITION

MODELS: 1989-1995 GEO TRACKER, CAMI VITARA, SUZUKI SIDEKICK
WITH HYDRA-MATIC 3L30 AUTOMATIC TRANSMISSION

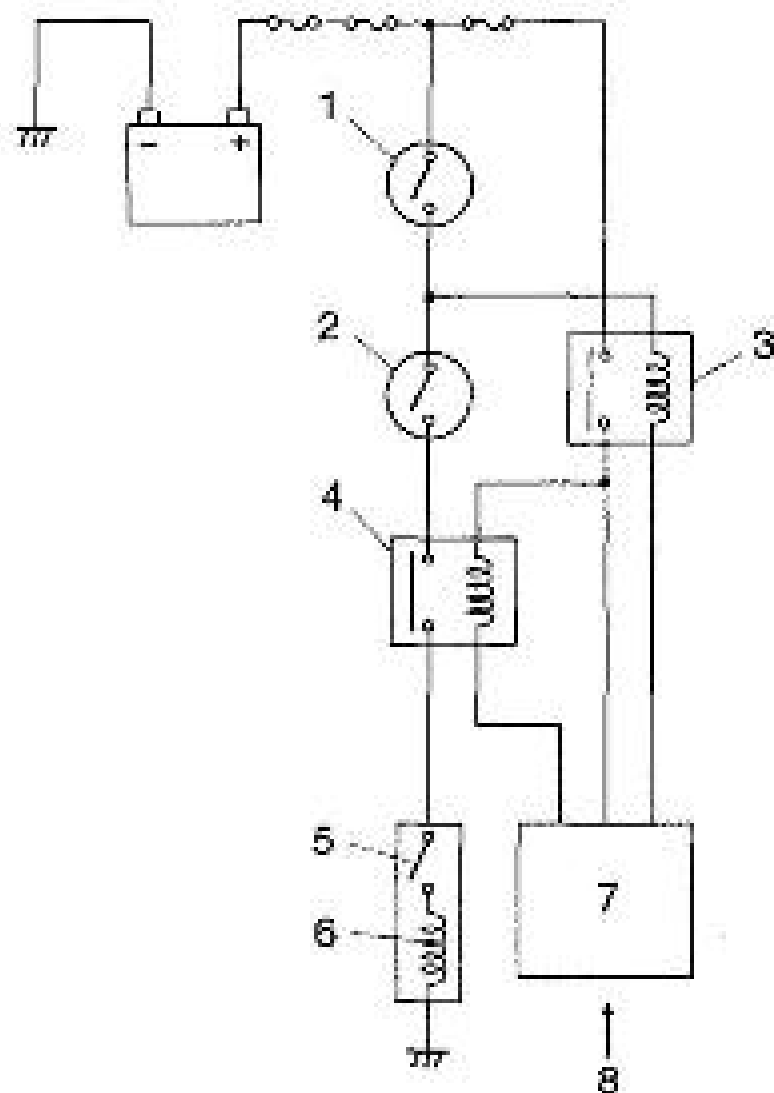
Figure 1

TORQUE CONVERTER CLUTCH (TCC) RELAY CONTROL SYSTEM (3 A/T)

This system controls the TCC relay, one of the components that controls the torque converter clutch. A circuit diagram of this system is shown in Figure 1.

The TCC solenoid valve, under the control of the A/T oil pressure switch and TCC relay, opens and closes the A/T oil passage to lock and unlock the torque converter clutch.

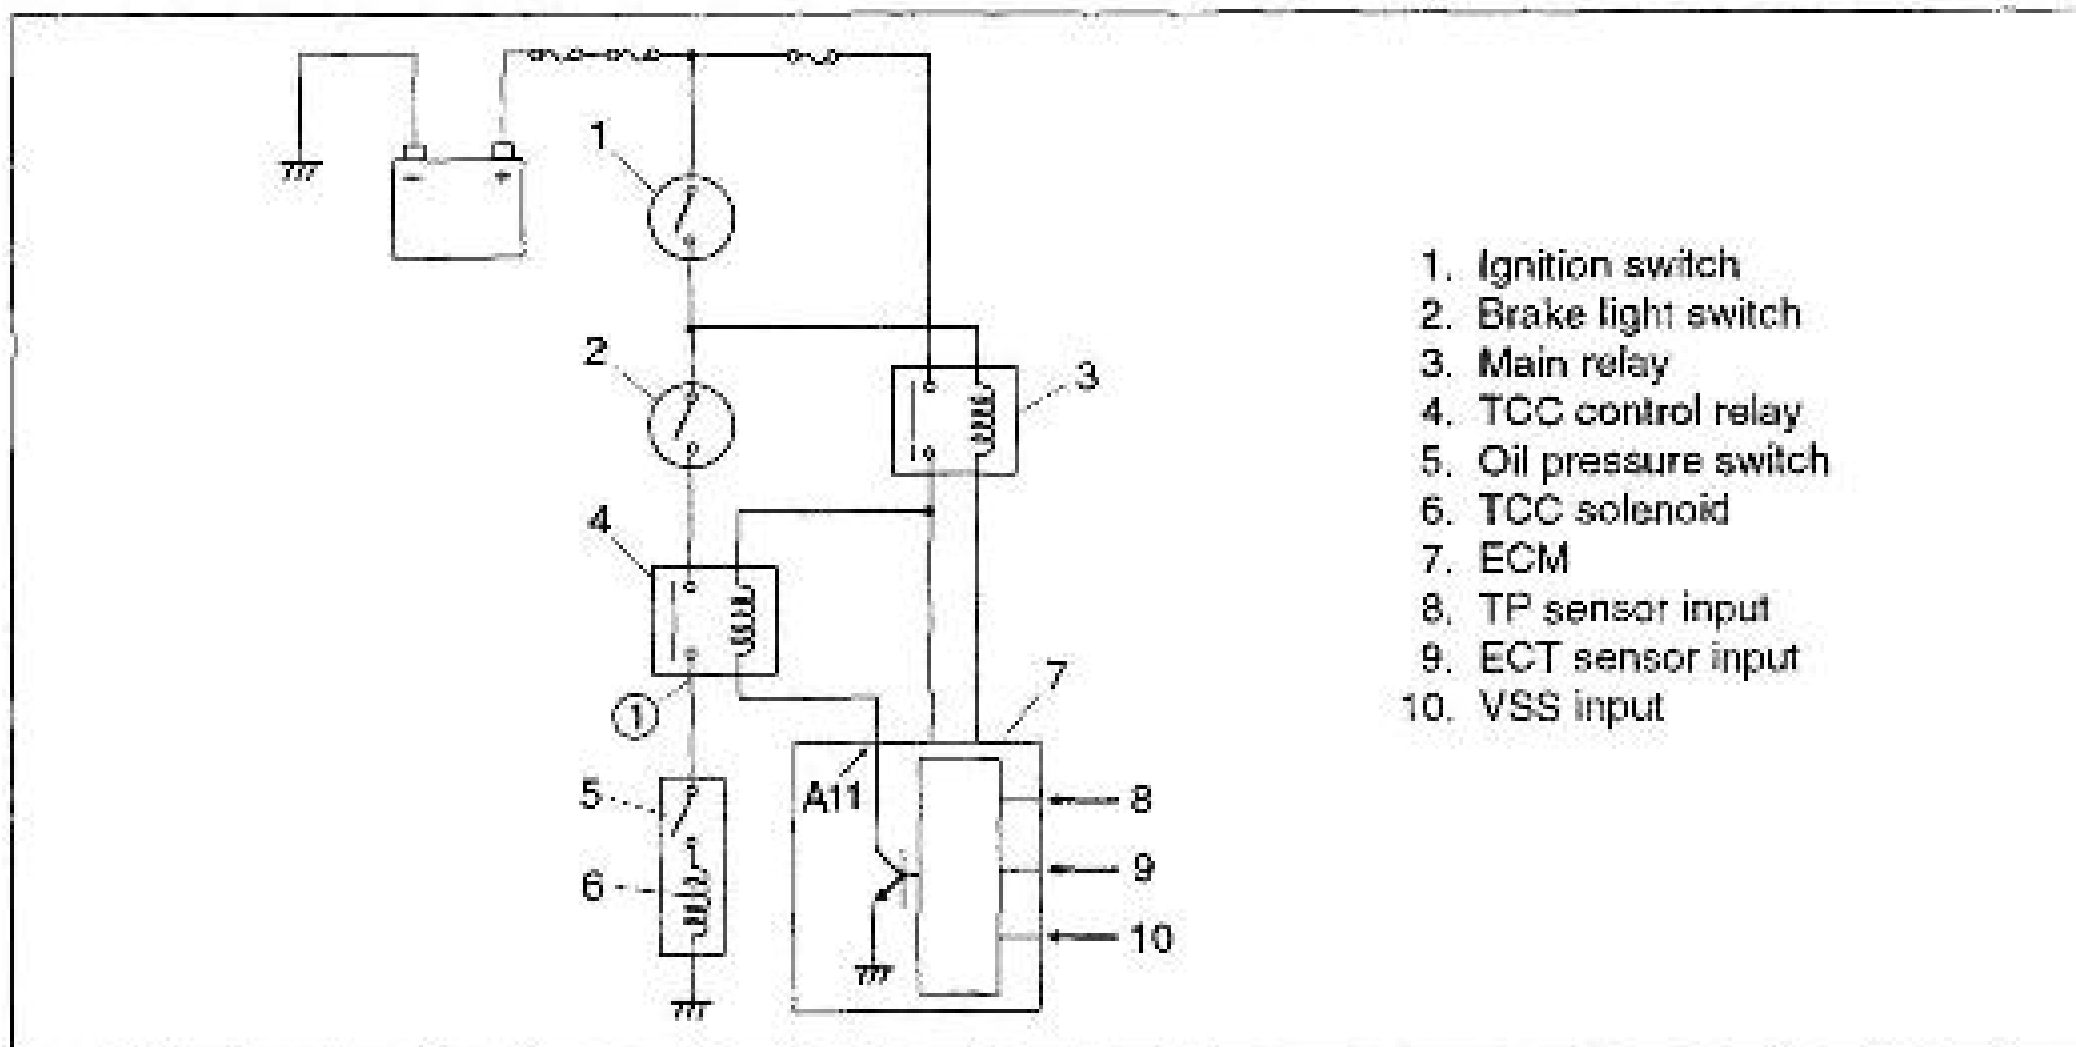
1. Connect a voltmeter between A11 terminal of the ECM coupler and body ground with ignition switch OFF.
2. Check voltage with ignition switch ON. Is it 10-14 V?

3. Shift select lever to "D" range and accelerate vehicle on lift.
4. As the vehicle speed increases, does voltage indicated by the voltmeter change from 10-14 V to 0-1 V at about 47 mph (75 km/h, 16-valve engine), 40 mph (64 km/h, 8-valve engine) or higher speed?

1. Connect a voltmeter between terminal ① of the TCC relay and ground.
2. Check voltage with ignition switch ON. Is it 0-1 V?

Poor A11 connection. If connection is OK, substitute a known-good ECM and recheck.

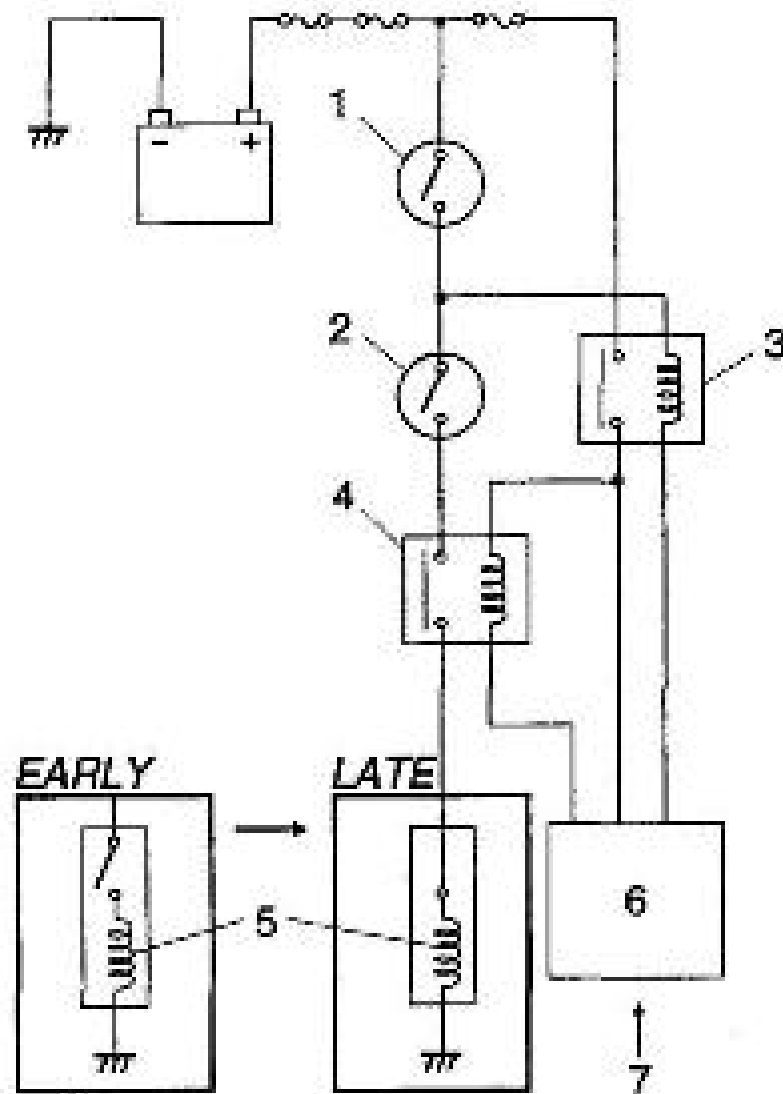
Figure 1

TORQUE CONVERTER CLUTCH (TCC) RELAY CONTROL SYSTEM (3 AT)

This system controls the TCC relay, one of the components that controls the torque converter clutch. A circuit diagram of this system is shown in Figure 1.

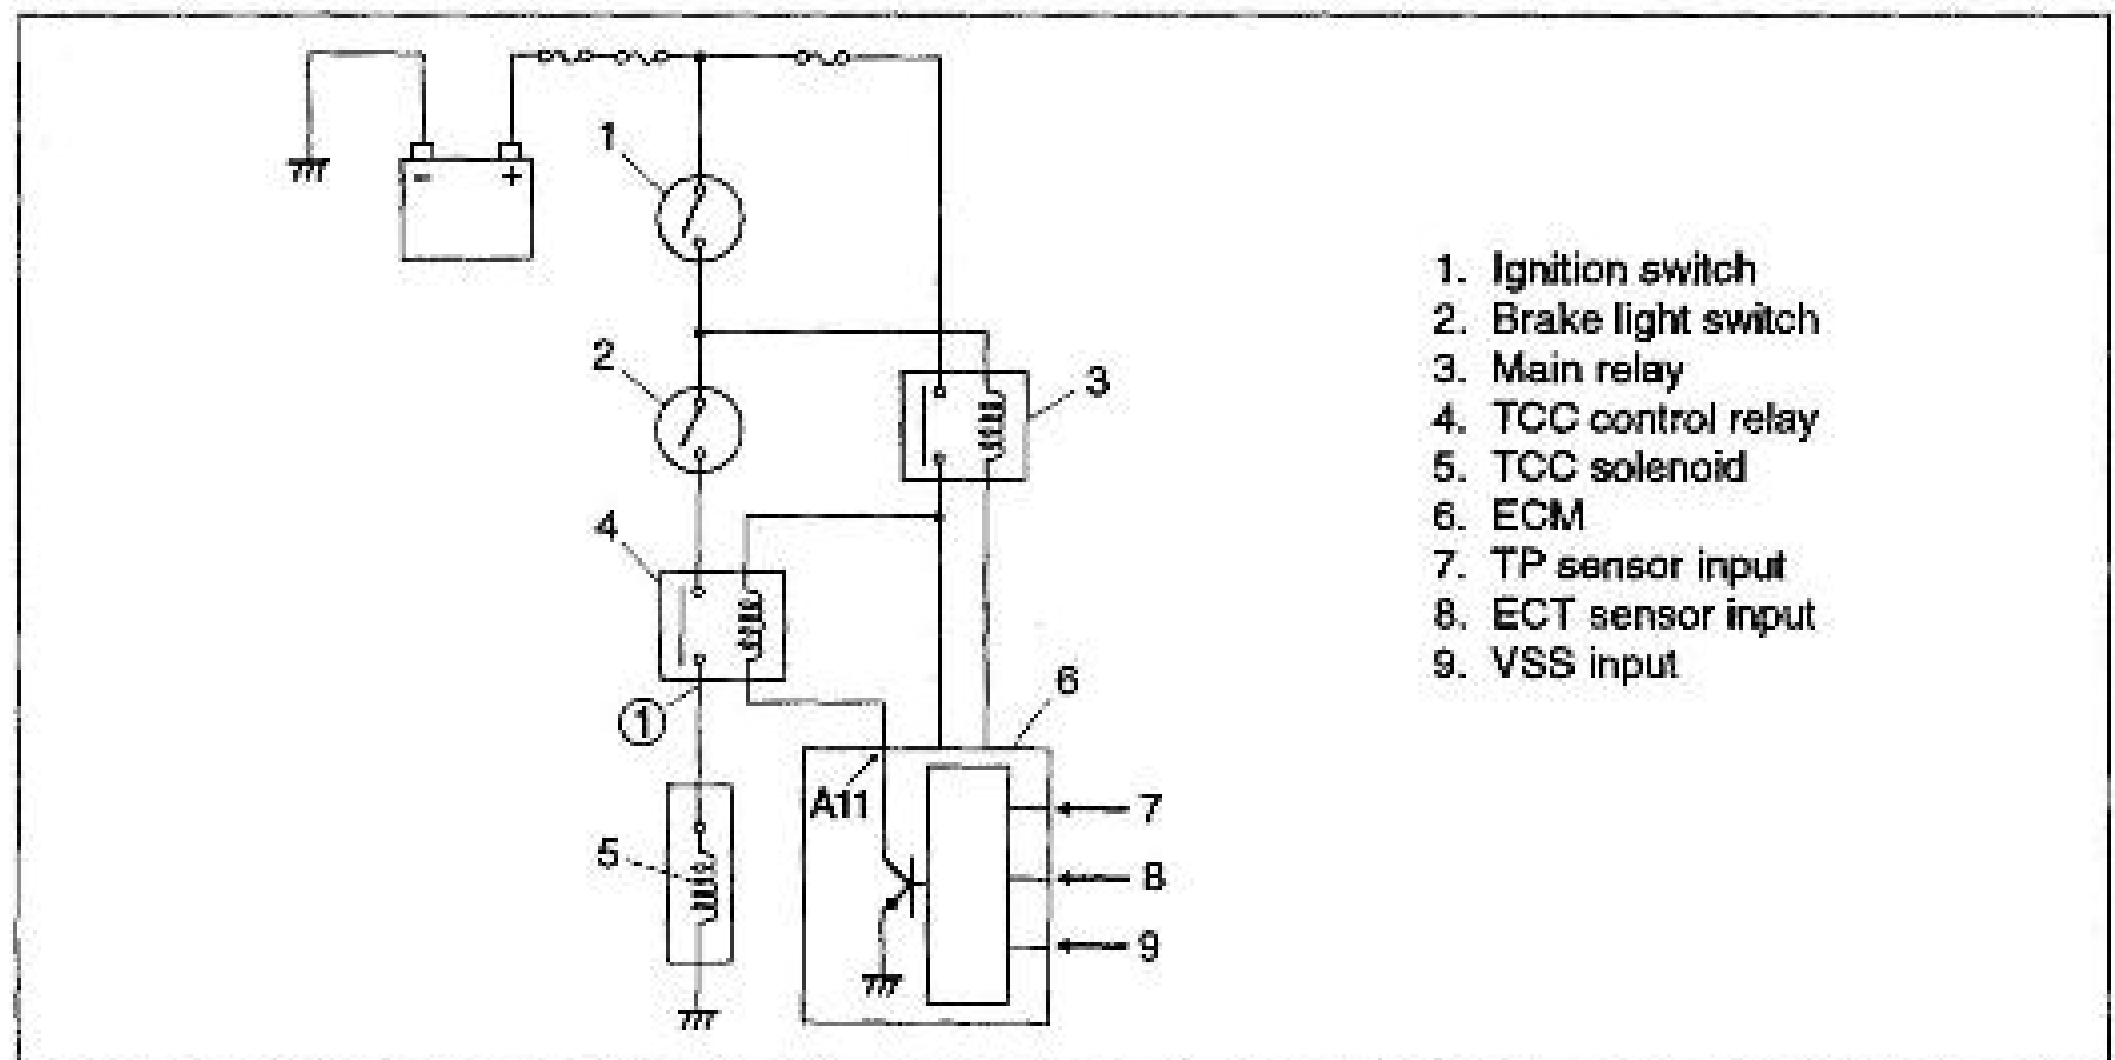
For diagnostic procedure, please refer to Technical Service Bulletin #TS 3-25. Also note that the continuity check between ① pin of TCC relay coupler and ground is not needed due to the elimination of the A/T oil pressure switch.
