Bulletin No.:	9573L30-01
Corp. Ref. No.:	57-71-09
Date:	April, 1995

Product Service Bulletin

SUBJECT: TORQUE CONVERTER CLUTCH (TCC) CHUGGLE/HUNTING CONDITION

MODELS: 1989-1995 GEO TRACKER, CAMI VITARA, SUZUKI SIDEKICK WITH HYDRA-MATIC 3L30 AUTOMATIC TRANSMISSION

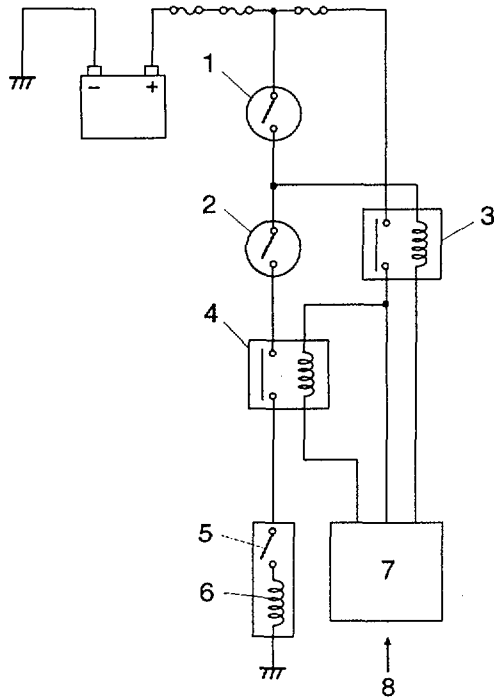
Figure 1

CONDITION: Change in diagnosis of TCC Relay Control System.

CAUSE: Modification in the ECM.

TORQUE CONVERTER CLUTCH (TCC) RELAY CONTROL SYSTEM (3 A/T)

This system controls the TCC relay, one of the components that controls the torque converter clutch. A circuit diagram of this system is shown in Figure 1.

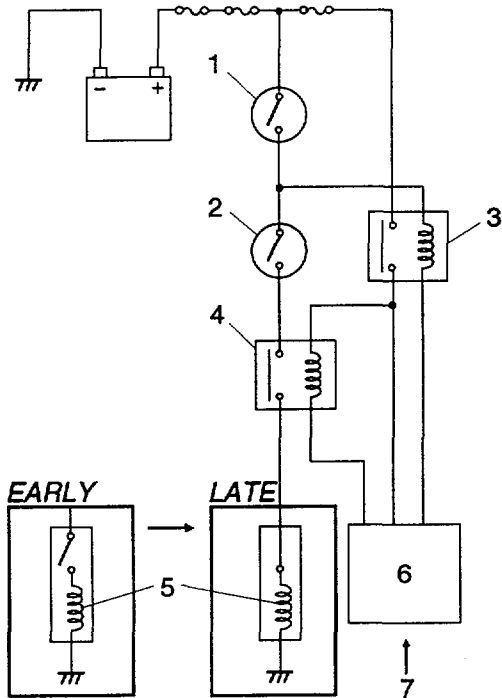
Figure 1

CONDITION: Change in Automatic Transmission; elimination of A/T oil pressure switch.

CAUSE: Factory modification.

TORQUE CONVERTER CLUTCH (TCC) RELAY CONTROL SYSTEM (3 A/T)

This system controls the TCC relay, one of the components that controls the torque converter clutch. A circuit diagram of this system is shown in Figure 1.

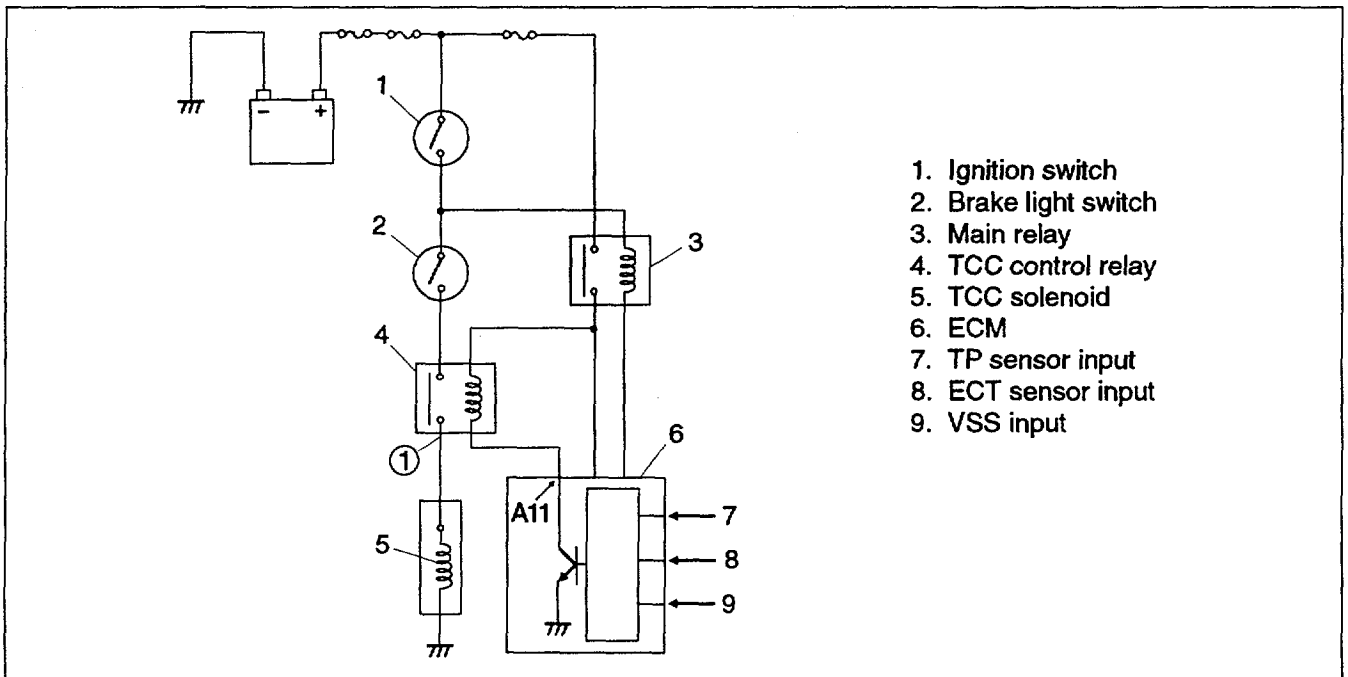
For diagnostic procedure, please refer to Technical Service Bulletin #TS 3-25. Also note that the continuity check between ① pin of TCC relay coupler and ground is not needed due to the elimination of the A/T oil pressure switch.
